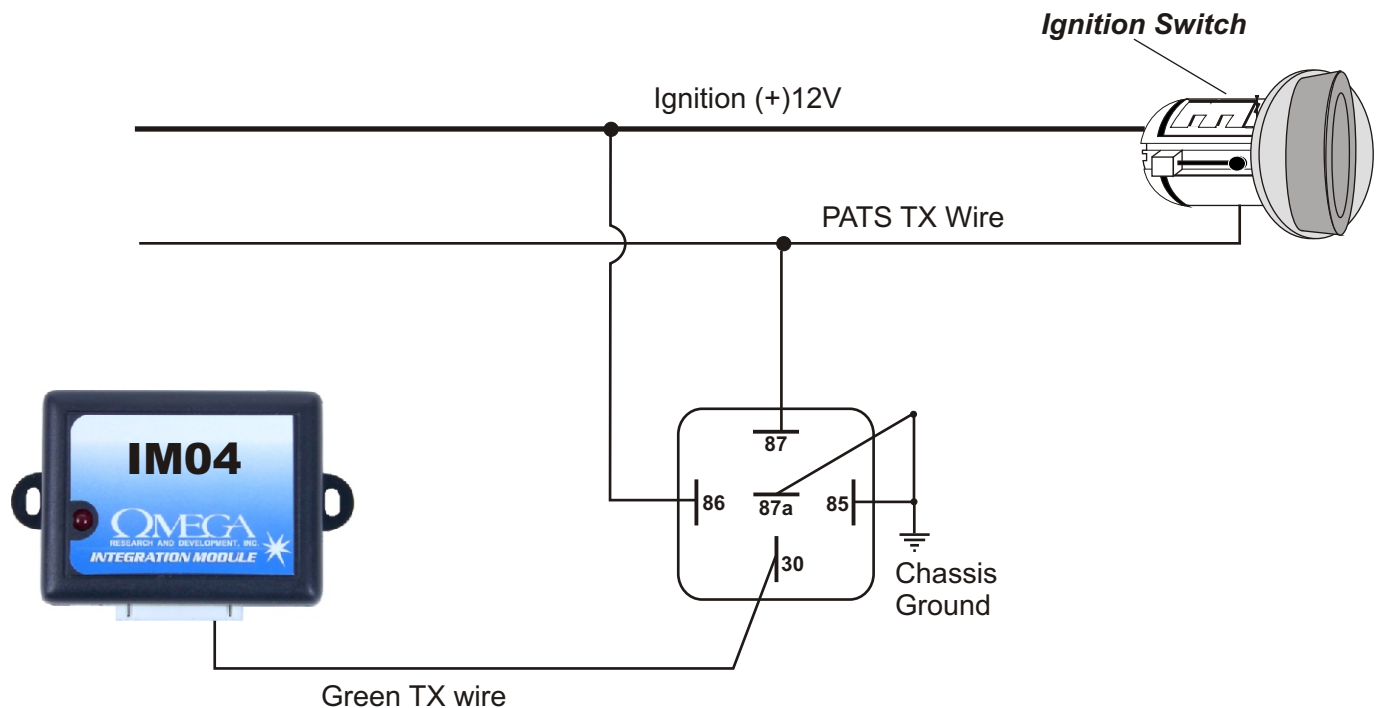
Some newer vehicles and certain generations of Ford's PATS have a voltage spike issue that can lock up the IM04. This simple diagram will isolate the IM04's TX wire to prevent seeing the spike by connecting it only when the ignition is in the "ON" or "RUN" position. Make all other connections as described in the installation guide for the IM04.
